Yarmouth's Royal River Fishways

Frequently Asked Questions

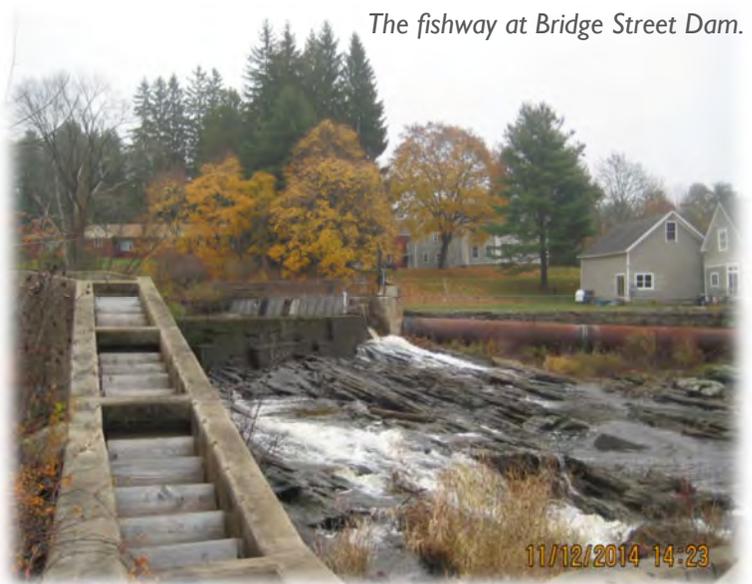
The fishway at Bridge Street Dam.

Bridge St. dam fishway - In addition to needing repairs & maintenance, constraints include:

- ◆ Does not meet the current design standards for shad (too steep and narrow, with too many sharp bends)
- ◆ Lacks juvenile eel passage (for spring migration)
- ◆ Lacks intentional downstream fish passage (increasing injury/death during outmigration)
- ◆ Is inadequately sized to meet standards for anticipated run populations, and for resting pool areas
- ◆ Competes with hydropower operations at Sparhawk Mill, attracting fish to the mill outflows
- ◆ Provides insufficient attraction flow at fishway entrance, competing with flow dispersed over the ledge falls

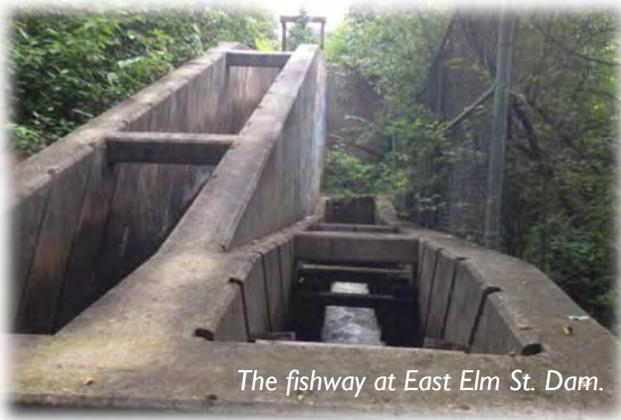
The fishway at East Elm St. Dam.

E. Elm St. dam fishway - A complete rehabilitation would be needed to regain operability and functionality, including replacement of weirs, gates, trash racks & control structures. Additional constraints:

- ◆ Entrance is blocked with boulders, & adjacent channel requires modification
- ◆ Entrance configuration is very poor, with water flowing across the entrance
- ◆ The stop log weir is in disrepair and blocked with debris, negating its use in managing flow
- ◆ Outflow from the foundry by-pass channel forms a competing attractant flow
- ◆ Does not meet the current design standards for shad (too steep and narrow, with too many sharp bends)
- ◆ Lacks juvenile eel passage (for spring upstream migration)
- ◆ Lacks intentional downstream fish passage (increasing injury/death during outmigration)
- ◆ Inadequately sized to meet standards for anticipated run populations, and for resting pool areas
- ◆ Provides insufficient attraction flow at fishway entrance, competing with currents dispersed over the ledge
